Malaysian Journal of Geosciences (MJG)

RESEARCH ARTICLE ENGINEERING GEOLOGICAL INVESTIGATION ON KARAMBUNAI-LOK BUNUQ LANDSLIDES, KOTA KINABALU, SABAH

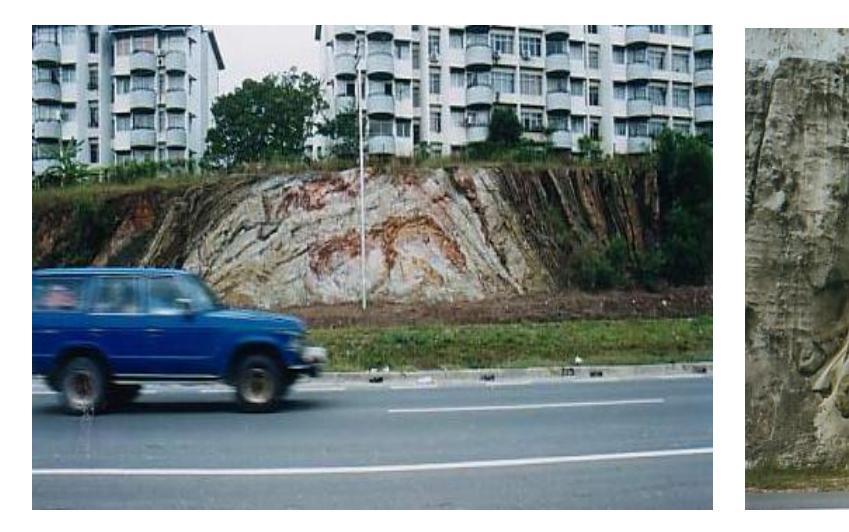
The geology of the study area is made up of two sedimentary rock formations: the Crocker Formation (Miocene to Late Eocene age) and Quaternary Alluvium (Recent age) (Figure 4). The effect of faulting and folding activities can be observed on the lithologies in the study area (Figure 5). This was confirmed by the existence of transformed faulted material consisting of angular to sub angular sandstone fragments, with fine recrystallined quartz along the joint planes, poorly sorted sheared materials and marked by the occurrence of fault gouge with fragments of slickensided surfaces. Breaks and fractures were developed by shearing stresses that caused the rapid disintegration and weathering of the rocks into relatively thick soil deposit. As a corollary to this, in rock bodies, the surface roughness of joint are generally smooth to rough planar. A relatively smooth surface decreases the frictional resistance to expose the fractures, therefore effected the possibility of landslide occurrences in

Figure 5: The presence of faulting and folding activities on the lithologies (a: Telipok & b: Kastam quarters)

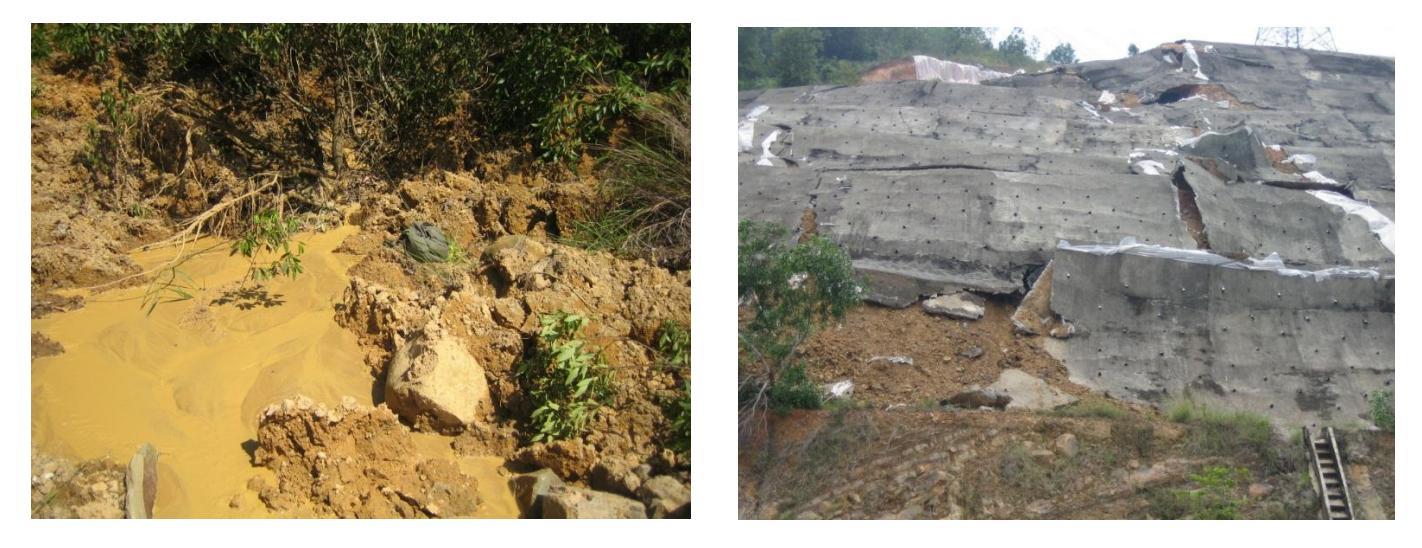
The study area consists mainly of beach deposits along the beach area, alluvial deposit mostly in the valley and swamp area and sedimentary rocks of the Crocker Formation. Based on the field observation, the study area is located within the area of sedimentary rocks which has a locally significant occurrence of groundwater, while some area are of unconsolidated sediment (beach deposit and alluvial deposit) and areas with no significant occurrence of groundwater. These sedimentary rocks are made up principally of interbedded sandstone-shale sequences, occasional breccias units and alluvial deposit that have limited primary porosity and moderately well-developed secondary porosity. The areas where there are no significant occurrences of groundwater are made up principally of shale unit sequences. On the others view, it is indicated that the spring flowing follow the topography from highland toward the road and the valley sides (Figure 6). The weathered materials are weak and caused landslide due to high fractured porosity and high pore pressure subjected by both shallow and deep groundwater.

Figure 6: The surface water shows that it's flowing strongly into the road drain and local villages (a: Karambunai landslide & b: Lok Bunuq landslide)

- a) Sealing off of the cracks;
- b) Shot Crete or other means of reducing erosive action of rainwater runoff.
- c) Retaining wall with bore piles.
- d) Subsurface drainage, i.e. horizontal drainage method.

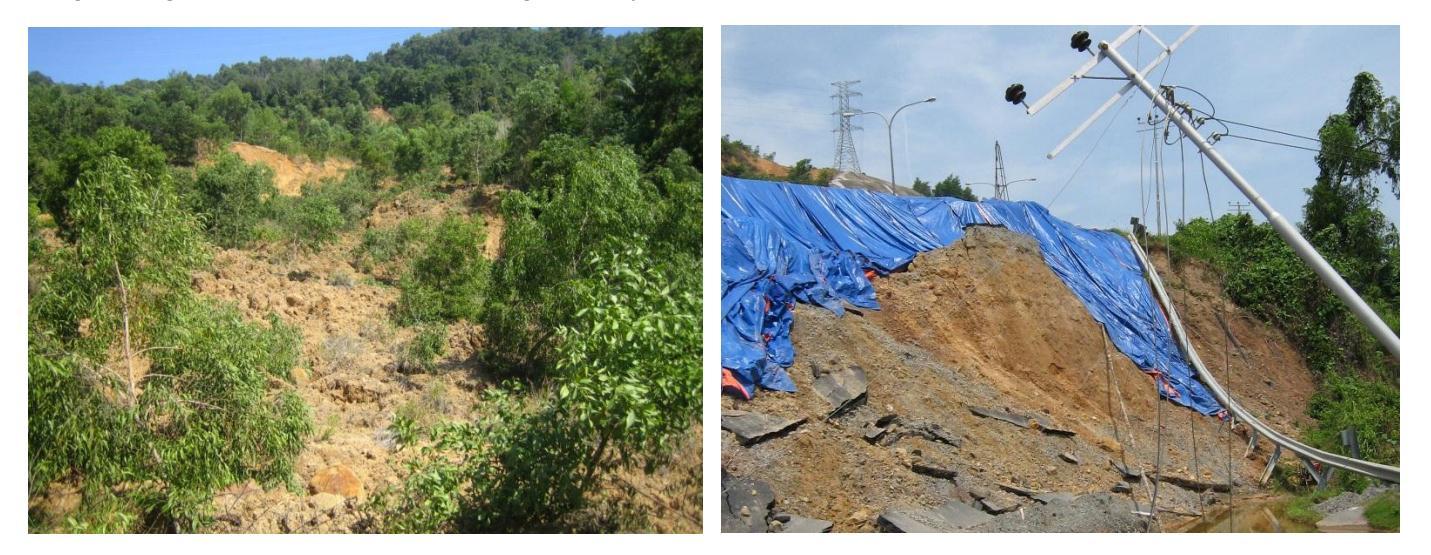
and engineering properties of eight (8) soil samples indicated that the failure materials mainly consist of poorly graded materials of sandy clay soils, which characterized by low to intermediate plasticity, containing of normal clay (0.42 to 0.95), very high degree of swelling (5.63 to 10.35), variable low to high water content (11.95 % to 19.92 %), specific gravity ranges from 2.60 to 2.68, low permeability (6.68 X 10⁻⁴ to 1.52 X 10⁻⁴ cm/s), friction angle (ϕ) ranges from 18.50° to 34.20° and cohesion (C) ranges from 3.36 kN/m² to 19.50 kN/m² with very soft to soft of undrained shear strength (9.47 kN/m² to 32.30 kN/m²). Slope stability analysis shows that the factor of safety value is ranges from 0.805 to 0.817 (unstable) (Figures 10 & 11). The presence of ground water, slope angle, removal of vegetation cover, lack of proper drainage system, artificial changing, intensive weathering process and geological characteristics are additional factors contributing to the failures.

Figure 7: Landslides generally consisting of fine texture, cohesive materials, completely weathered to residual soil materials (a: Karambunai landslide & b: Lok Bunuq landslide)

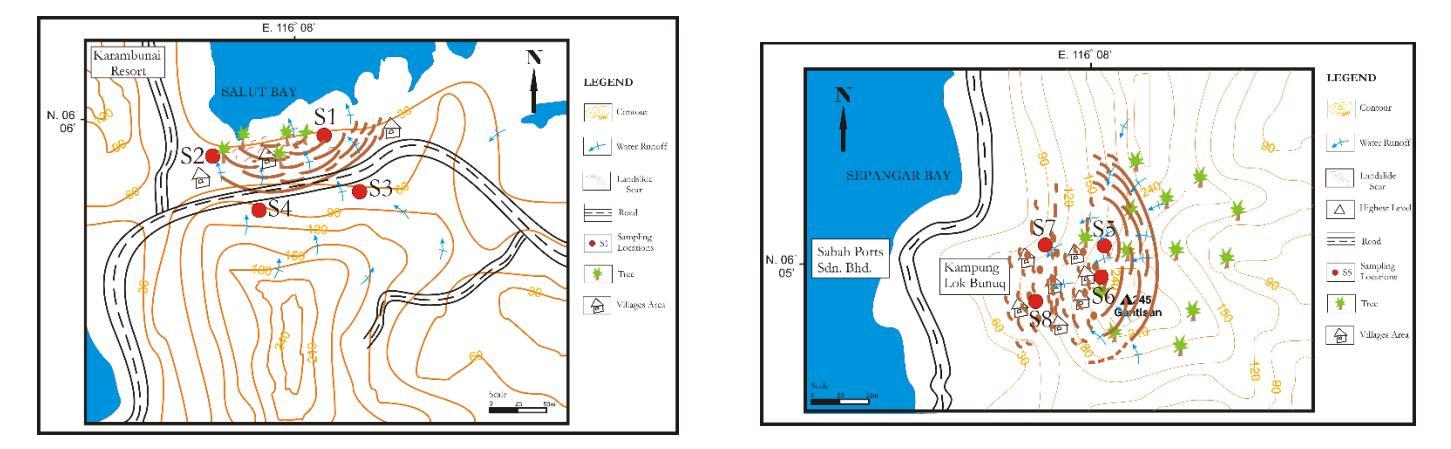
Figure 8: Rotational Slide showing the failure movement are starting from the hill side to the road and/or village sides through the development of water runoff (a: Karambunai landslide & b: Lok Bunuq landslide)

The compositions of the slip mass, the speed of slope movement, the manner in which it moved, and the lobate form of its toe, classify the major movement as a debris flow. Rotational slide occur when poorly sorted brecciated and clayey materials, saturated with water, surge down slopes under gravitational action and characterized by the sudden collapse and extensive, very to extremely rapid run-out of a mass of debris material following some disturbance [5]. An essential feature is that the material involved has unstable, loose or high porosity structure. As a result of disturbance this collapses, transferring the overburden load wholly or partly onto the pore fluid, in which excess pore pressures are generated. The consequent sudden loss of strength gives the failing The consequent sudden loss of strength gives the failing material, briefly a semi-fluid character and allows a debris flow to develop.

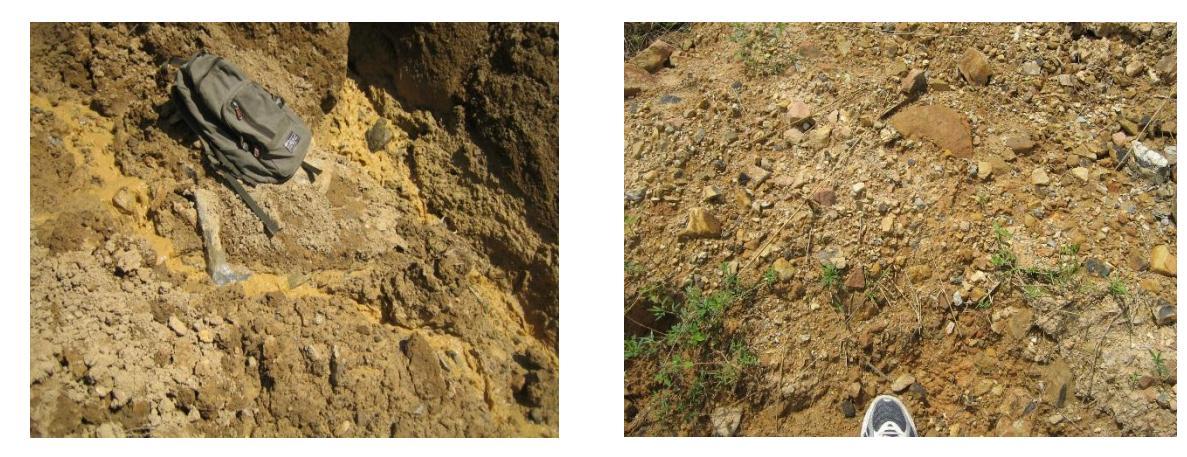
Figure 9: Failure materials which containing of clayey soil materials (a: Karambunai landslide & b: Lok Bunuq landslide)

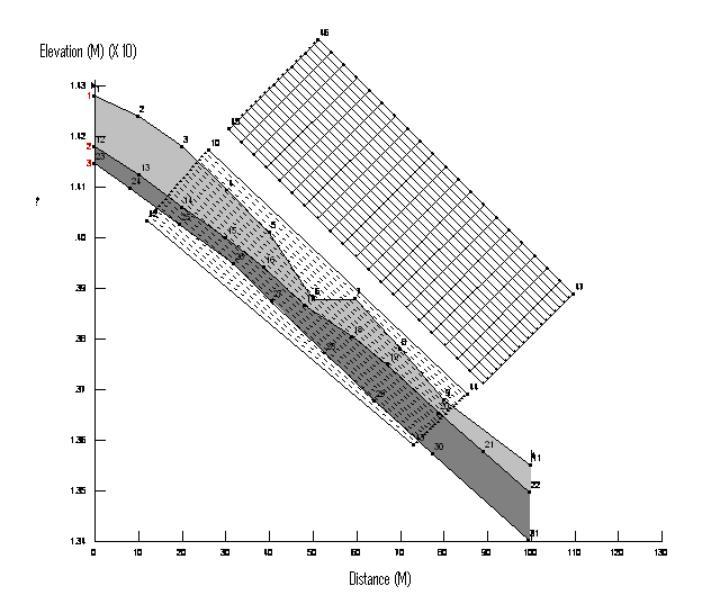
No.	Description	Minimum Factor of Safety			
	Analysis method	Moment	Force		
1	Ordinary	0.749	-		
2	Bishop	0.826	-		
3	Janbu	-	0.741		
4	Morgenstern – Price	0.819	0.817		
Slip surface # = 17 576 of 17 576

Figure 10: The results of slope stability analysis (Location: Karambunai landslide)

Slope stability analysis reveals that most of it occurring in sandy clay soil. Low to intermediate plasticity, high elasticity, friability and shrink - swell nature of the soil are just some properties, which characterized the sandy clay soils. The relatively high liquid limit and water content lead to a decrease in strength during rainy period when the limiting condition is reached, the material tends to behave like viscous liquid, which then easily slides. The sandy clay soils with a low permeability of inert particles in the study area have a high porosity and more porous. Porous soils allow for rapid infiltration of surface water to the lower layers. Additionally, the surface water was found flowing strongly into the road drain and local villages [4]. This limits the destabilizing effect of accumulated water on the upper soil layer. The draw back here is that clayey soils tend to be very weak, friable and easily transported by flowing surface water and this would seriously weaken the shear strength of the soils slopes, causing high chance for slope failure to occur. Slope stability analysis shows that the factor of safety value for the soil slope failures ranges from 0.805 to 0.817 (Unstable).

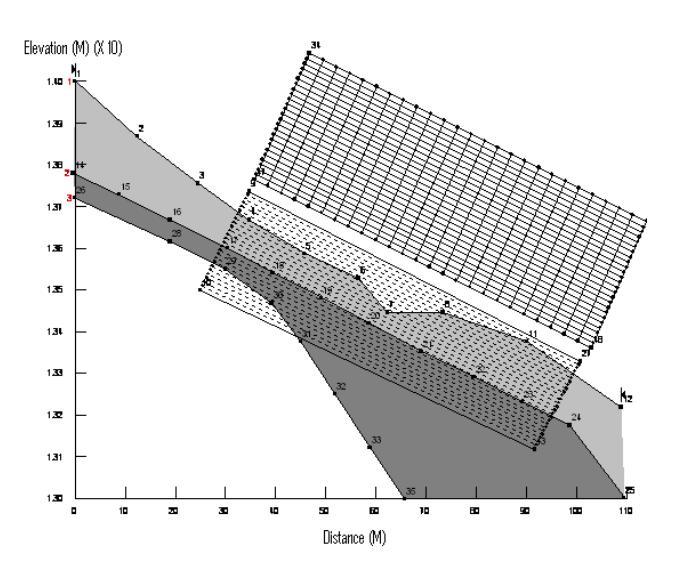
No.	Description	Minimum Factor of Safety			
	Analysis method	Moment	Force		
1	Ordinary	0.785	-		
2	Bishop	0.819	-		
3	Janbu	-	0.781		
4	Morgenstern – Price	0.812	0.805		
Slip surface $\# = 9261$ of 9261

Figure 11: The results of slope stability analysis (Location: Lok Bunuq landslide)
