Consequently, emphasis will however be placed on the pathway which is the medium by which contaminant flow between the source and the receptor. Therefore, this paper focuses on assessment of the geotechnical and hydrological properties of vadose zone around burial sites in Ede and Iragbiji areas of Osun State, Nigeria. It considers the index and engineering properties of the soil within the vicinity *viz-a-viz* their suitability for the purpose and impacts of the decay of the human corpse on the physico-chemical, chemical and biological properties of groundwater within the study areas.

2. STUDY AREA

3. METHODOLOGY

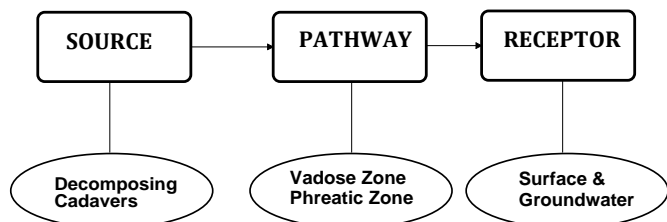
Figure 1: Conventional Approach to Environmental Risk Assessment. (Source; William et al. 2009)

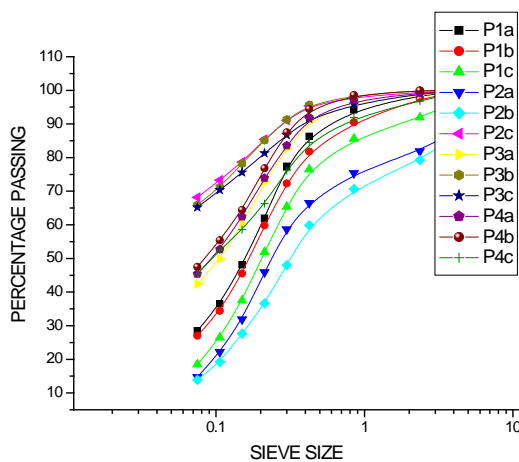
Figure 4: Grain Size Distribution Curves of the Soil Samples

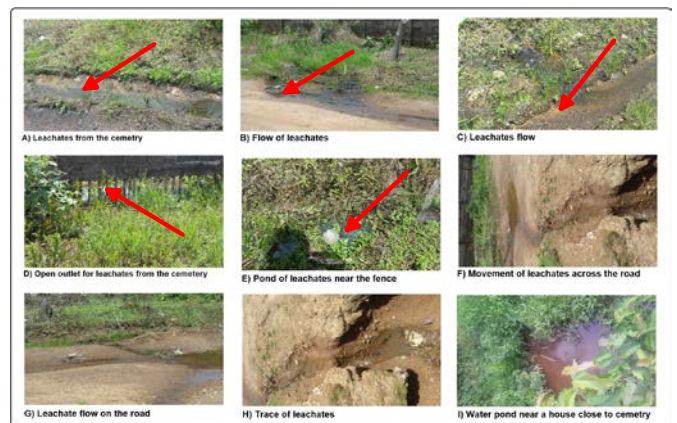
Figure 7: Field Pictures of Flow of Leachate from Cemetery to A Body of Water.

In siting a cemetery, index properties of soil in terms of its grain size, packing density, permeability and degree of porosity dictates to a large extent the rate and ease of fluid movement within a medium. For instance, coarse grained soil present in most of the study areas would allow rapid infiltration of fluid which invariably transmits decomposition fluid to the underlying formation or increase the potentials of groundwater contamination within the subsurface. This could conceivably be a cause of local epidemics from waterborne diseases where the surface or groundwater is used as a water source. Characteristic of soils primarily control the potentials of unsaturated zone in acting as a filter of wastes and cadavers buried within it. The prevailing particle size distribution of the soil influences the hydrogeological characteristics of the formations. It controls the porosity and permeability which are the key parameter for percolation and movement of fluids within the unsaturated vadose zone. Other important factors lacking in both study areas, are the slope and distance of cemeteries to water abstraction points. Watershed areas should be considered before siting cemeteries. In other words, areas of high topography which may likely slope into streams and rivers should be avoided completely. Figure 6 illustrates the conceptual model of potential flow of contaminants within a typical cemetery close to rivers or streams. Pit 2 as observed in the field has a shallow water level of less than 3m which makes that section of the cemetery water-logged. Not only water-logged but a source of visible leachates from the cemetery. The proximity of shallow aquifers to cemeteries pose a great danger to the environment, as this reduces the time needed for mobile waste production to degrade completely and for the geological subsurface material to purify the potential pathogens. Evidence of this is presented in figure 6 showing a leachate flow right from inside the cemetery flowing to a water body (see traces in arrow according to figure 7) at about 20m away from the
