COMPARISON OF DIFFERENT TYPE OF FRICTION ANGLE IN KINEMATIC ANALYSIS

Ismail Abd Rahim*, Junaidi Asis, Mohamed Ali Yusuf Mohd Husin

Natural Disaster Research Centre (NDRC), Universiti Malaysia Sabah, Jalan UMS, 88400 Kota Kinabalu, Sabah

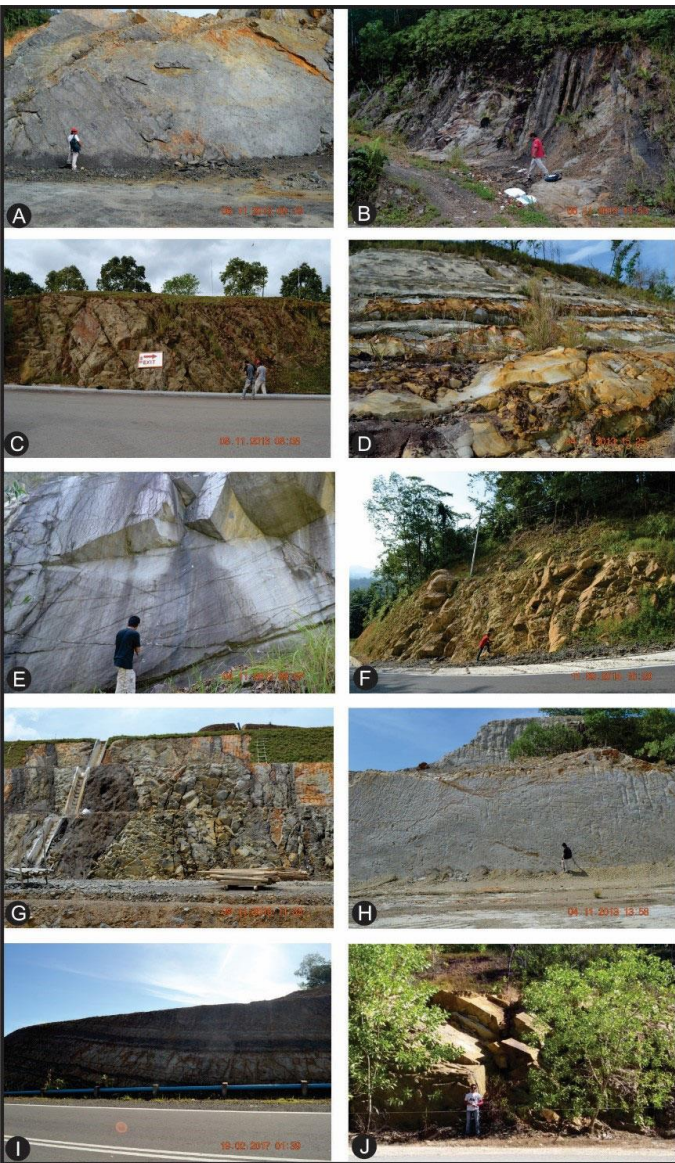
Figure 1: The selected slopes. Note: A- slope 1; B- slope 2; C- slope 3; D- slope 4; E- slope 5; F- slope 6; G- slope 7; H- slope 8; I- slope 9; J- slope 10.

slopes of the Crocker formation around Menggatal-Tuaran area, Sabah (Figure 1 and 2) are selected.

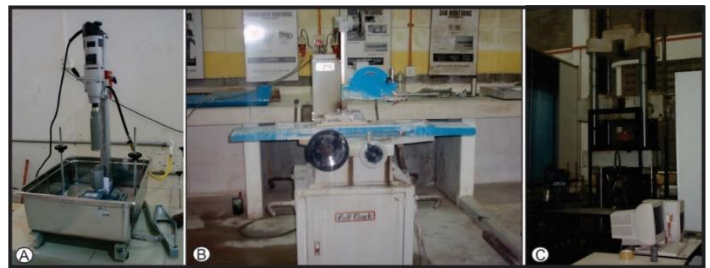
Figure 3: The coring machine, polishing and Hoek cell for triaxial test.

Triaxial test was conducted according to ISRM in Hoek cell as shown in Figure 3 [15]. The tilt test is also following ISRM but the samples types and arrangement [16]. The test is called as 'square type' which performed on square base slabs with 50mm x 50mm x 20mm dimensions (Figure 4).

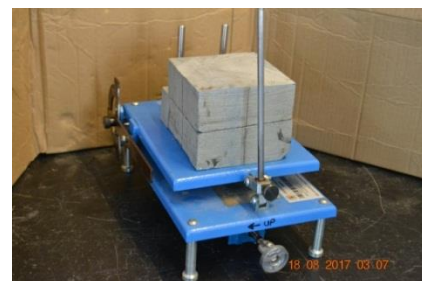
Figure 4: The tilt testing of square types samples.

- The specimens were cut according to the indicated dimensions using diamond core drill bits and saws.
- The lower specimens were placed on the plane-tilting platform in the horizontal position and secured in place.
- The upper specimens were placed on the fixed specimens in the horizontal position.
- All the samples are marked to monitor the movement and rotation during tilting process.
- The platform was progressively tilted at the rate of 0.4 mm/s until the upper specimens began to slide, and the tilt angle of the platform was recorded. Only tests corresponding to displacements of at least 10% of the sample length were taken into account.
- Each test was repeated for five (5) times.
- Results were calculated as the mean of the results for all the repetitions of each test.
